Reliability of CGA/LGA/HDI Package Board/Assembly (Revision A)

JPL Publication 12-3 2/12

NASA Electronic Parts and Packaging (NEPP) Program
Office of Safety and Mission Assurance

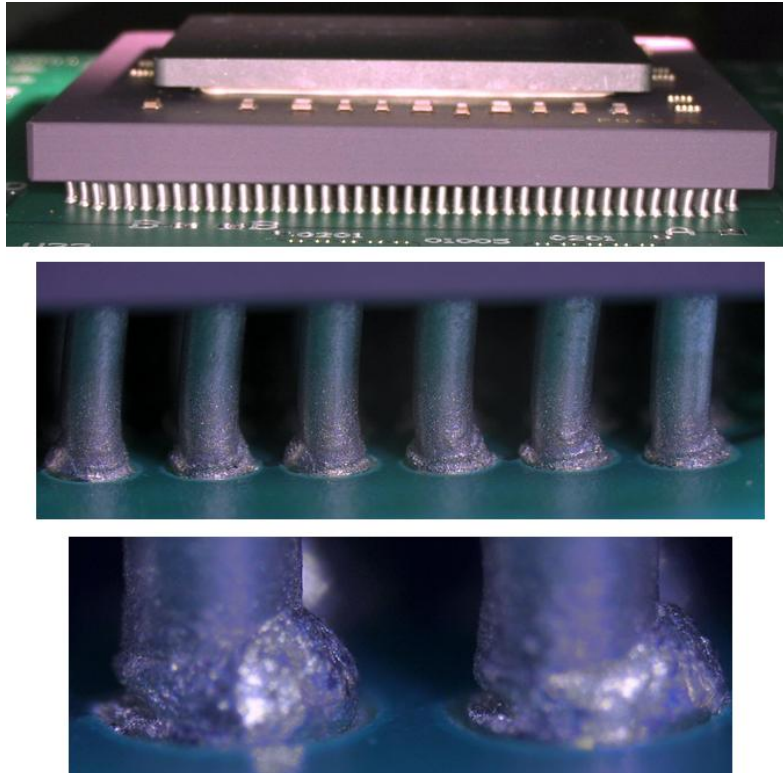
Figure 27. Representative photomicrographs of solder joint quality after 200 thermal cycles ($-55^{\circ}/125^{\circ}\text{C}$) for CGA1752.

Visual inspection was performed to establish damage progress of outer columns of CGAs at thermal cycling intervals by optical microscopy. Figures 26–27 present representative photomicrographs of solder joint condition and damage progress due to thermal cycling in the range of -55° to 125°C at 200 cycles. Damage due to thermal cycling, noticeable from these photomicrographs, can be categorized as follows:

Similarly to thermal cycle condition A, less deformation occurred for CGA1272 with lower package dimension and higher rigidity of columns—both factors induce lower thermal stress on solder joint attachment—compared to larger CGA1752 package and lower rigid pure solder columns. Note also that solder damage and microcracks induced especially for CGA1752 were generally significantly higher than those under A cycling condition.

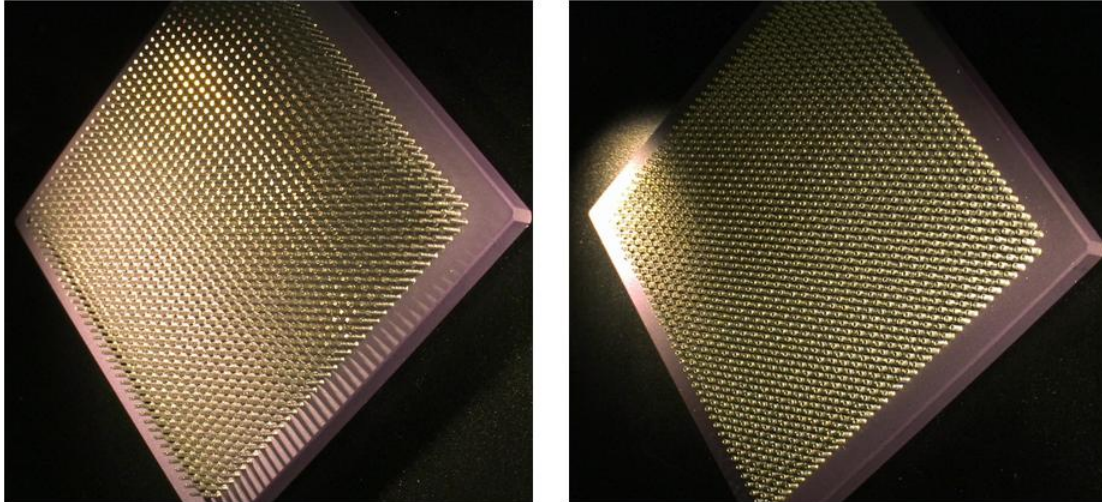
Figure 28. Representative photomicrographs of an LGA package after copper column (left) and micro-spring coil column (right) attachment.

This report covered many aspects of advanced area array packaging and high density printed circuit boards. The purpose of the following aspect of the investigation was to characterize the reliability of LGA1517 packages with 1-mm pitch. LGAs were subject to both copper-wrapped column and microspring coil attachment for subsequent evaluation. Column attachment integrity was evaluated by subjecting a CGA version to isothermal aging and pull tested before and at intervals during environmental aging. Figure 22 shows photomicrographs of the LGA package after it was transformed to CGA.

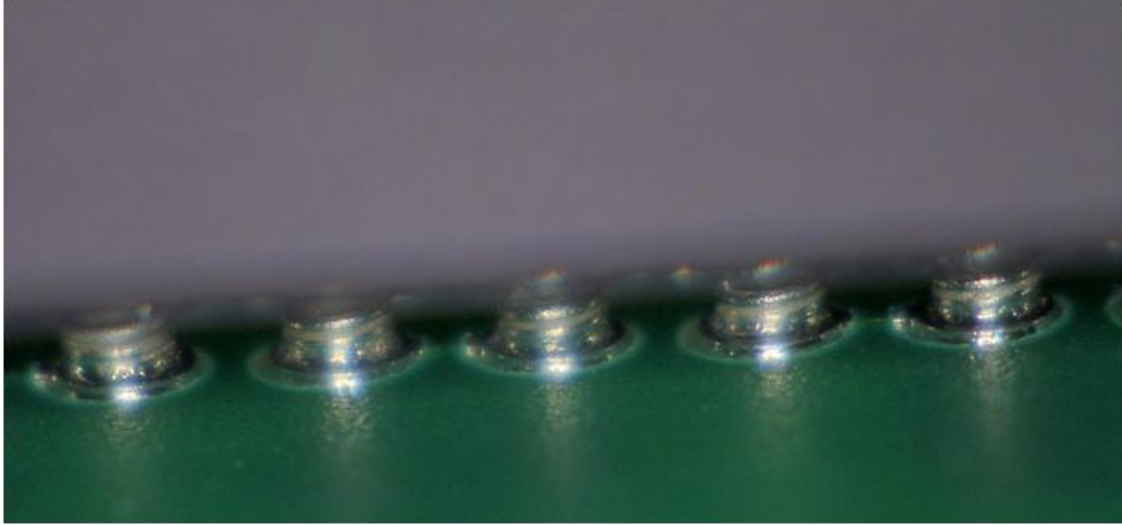
Figure 29. Representative photomicrographs of solder joint quality after assembly for microspring coil column CGA1571.

LGAs with copper-spiral solder columns and those with microspring coils were assembled onto two different PCBs with both standard and smaller pad diameters; this accommodated the two column/spring diameters. During the processing of LGAs with microspring coils, a CGA1272 was also assembled onto the board as a baseline for process and reliability evaluation. Visual inspection of peripheral columns was performed for these assemblies since the board was designed for visual characterization, especially since most of the PCBs were only populated with CGAs. Only outer rows, and in some cases, second and third rows, could be assessed for solder joint quality. Verification by daisy-chain resistance measurement was not possible since LGAs had no daisy-chain package design. The photomicrograph in Figure 29 shows the quality of solder joints for microspring coil of a column CGA assembly. Note that solder joint fillet formations are different since there are no solid solder columns; however, good quality solder fillet formation is apparent. Figure 30 shows solder joint quality of a copper-wrapped column assembly.

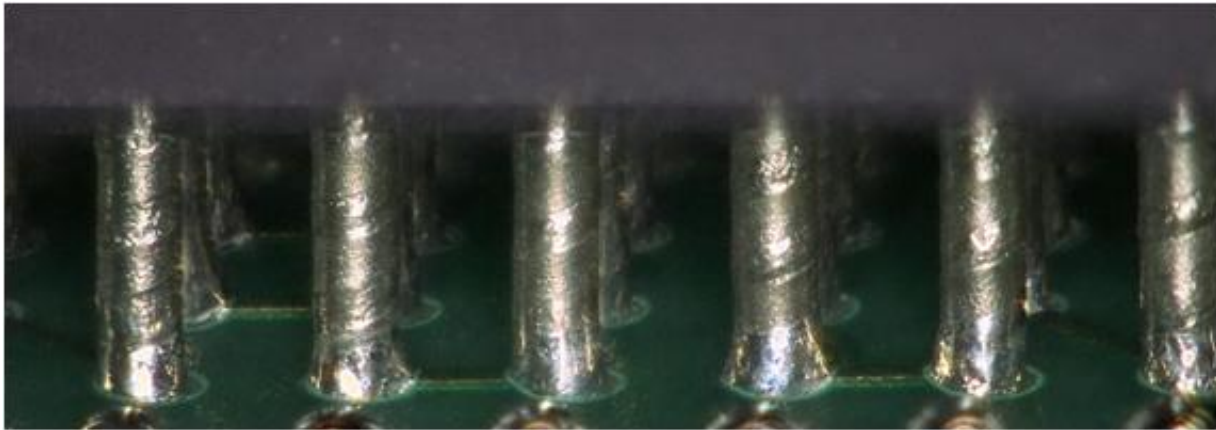
Figure 30. Representative photomicrographs of solder joint quality after assembly for CGA1571 with copper-wrapped solder columns.

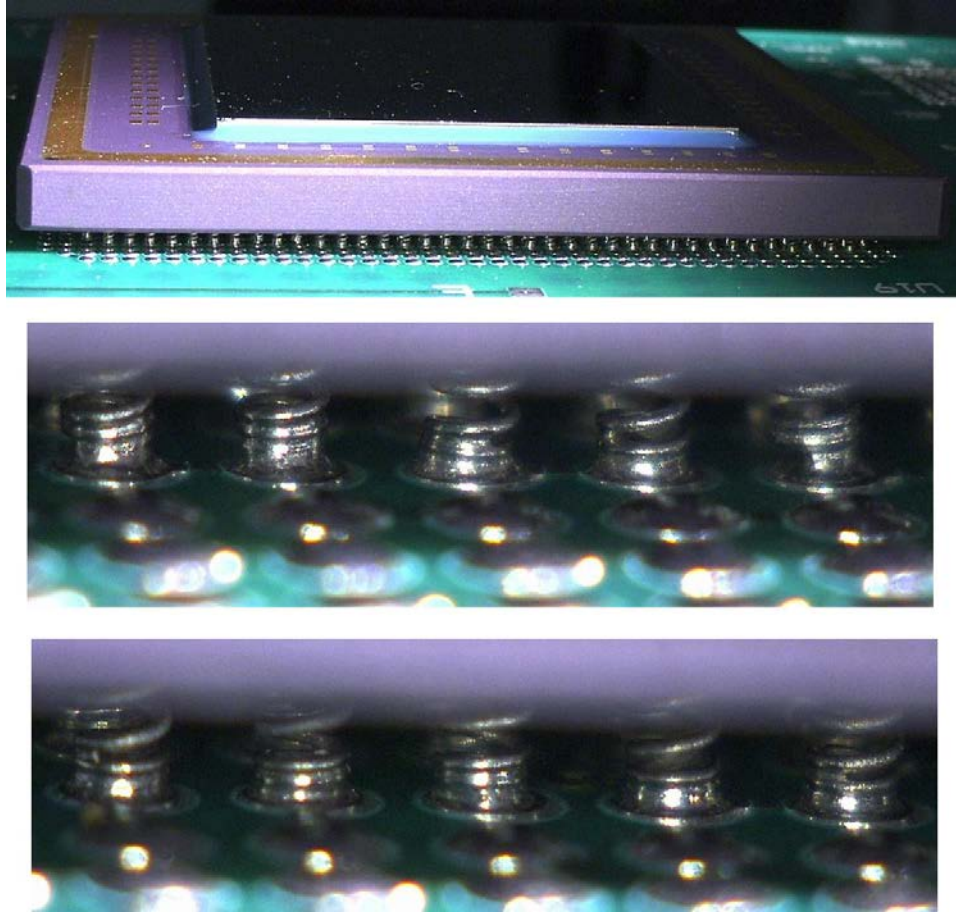
Figure 31. Representative photomicrographs of solder joint quality of microspring column attachment after 200 thermal cycles ($-55^{\circ}/100^{\circ}\text{C}$) for CGA1517.

In addition to daisy-chain monitoring for CGA1272, visual inspection was also performed by optical microscopy to establish damage progress of outer columns of all CGA assemblies at thermal cycle intervals. Figure 31 presents representative photomicrographs of solder joint condition of microspring columns and damage due to thermal cycling in the range of –55°C to 100°C at 200 cycles. Shiny appearance of solder joint reflection light from the microspring column attachment clearly indicates extremely minor damage induction due to 200 thermal cycling.

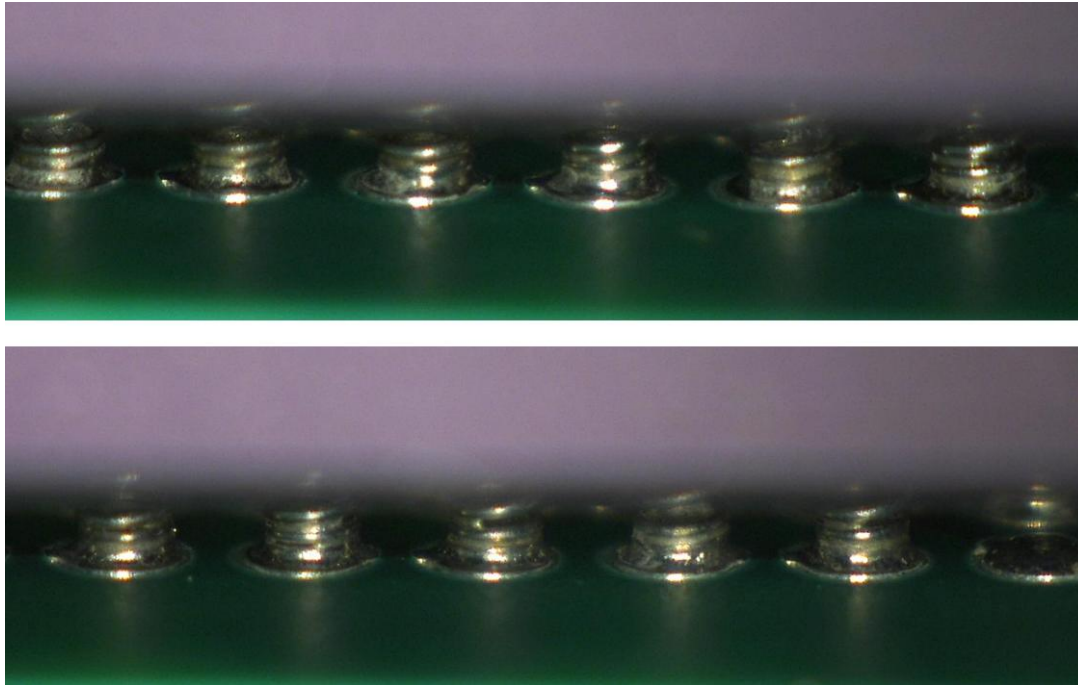
Figure 32. Representative photomicrographs of solder joint quality of microspring column attachment after 200 thermal cycles ($-55^{\circ}/125^{\circ}\text{C}$) for CGA1517.

In addition to daisy-chain monitoring for CGA1272, visual inspection was also performed to establish damage progress of outer columns of all CGA assemblies at thermal cycle intervals by optical microscopy. Figure 32 presents representative photomicrographs of solder joint condition of microspring columns and damage due to thermal cycling in the range of -55°C to 125°C at 200 cycles. Slight darker appearance of solder joints at the PCB side of microspring column attachments indicates minimum sign of damage due to 200 thermal cycling.

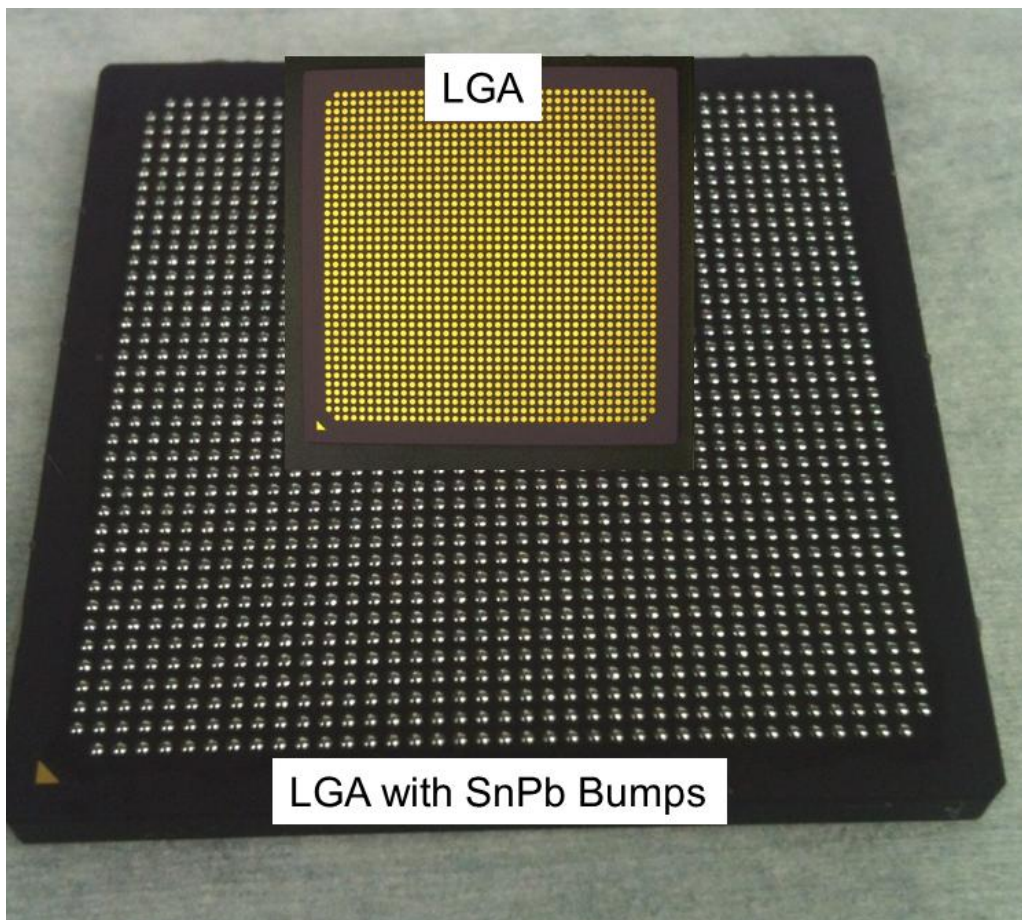
Figure 33. Ceramic land grid array (LGA) package as received (top) and with solder bumps generated by SnPb paste print and reflow (bottom).

Assembly procedure currently recommended for smaller size and plastic version of the LGA package using only solder paste for assembly is considered to cause significant solder bridges. To avoid bridging, the LGA1517 package was first subjected to tin-lead solder paste printing in order to increase solder height as well as to provide some control on standoff during subsequent assembly onto PCB. Solder paste was printed onto package and then reflowed to achieve solder bumps. This process was successful and generated uniform solder bumps with no bridging (see Figure 33).

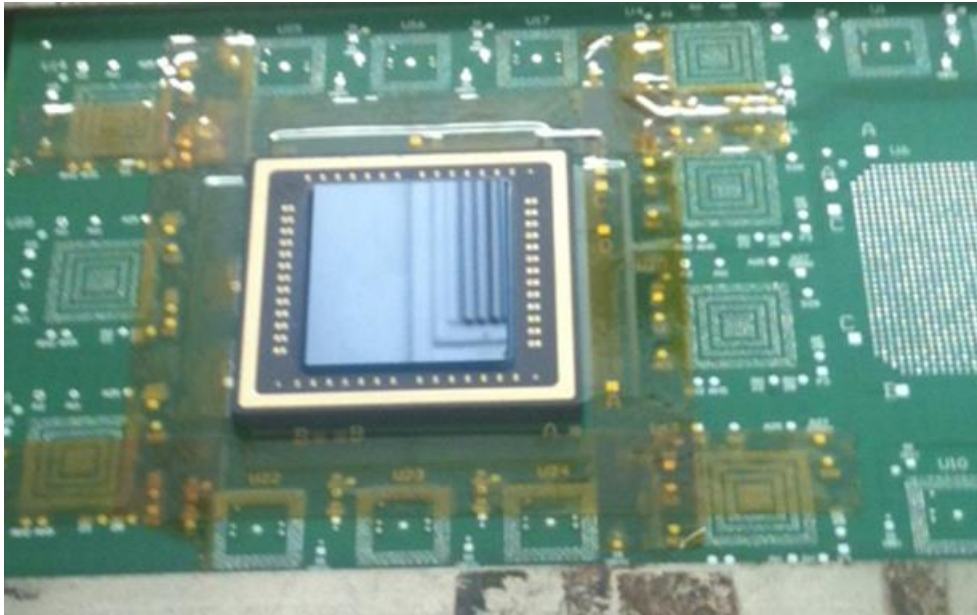
Figure 34. Ceramic land grid array (LGA) package with SnPb solder bumps assembled onto PCB.

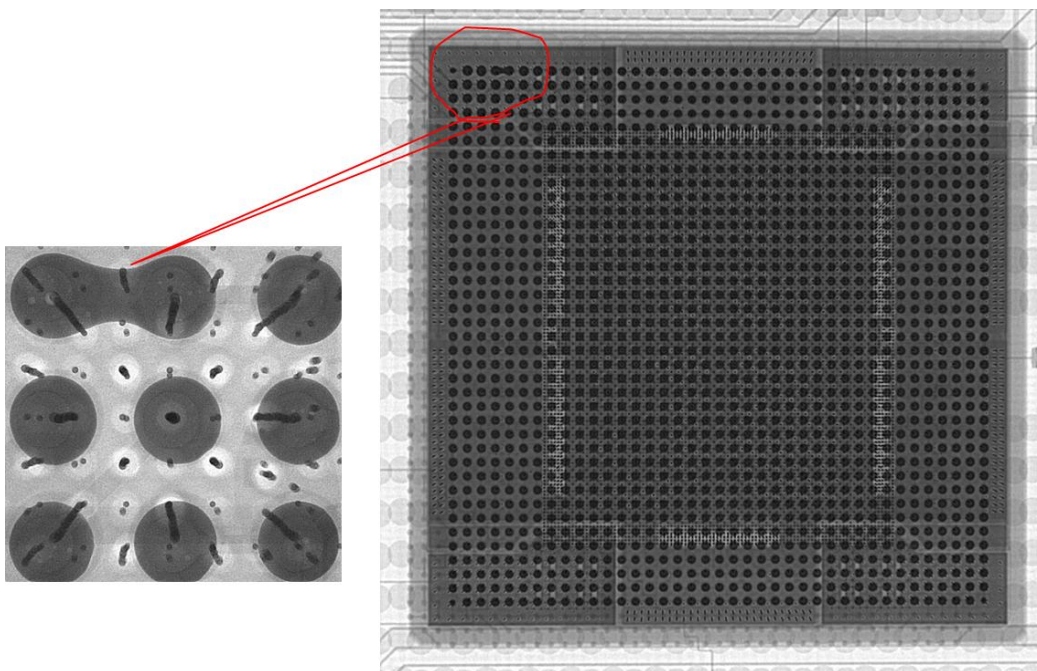
Figure 35. X-ray photomicrographs of assembled ceramic land grid array (LGA) package showing quality of assembly and one solder short.

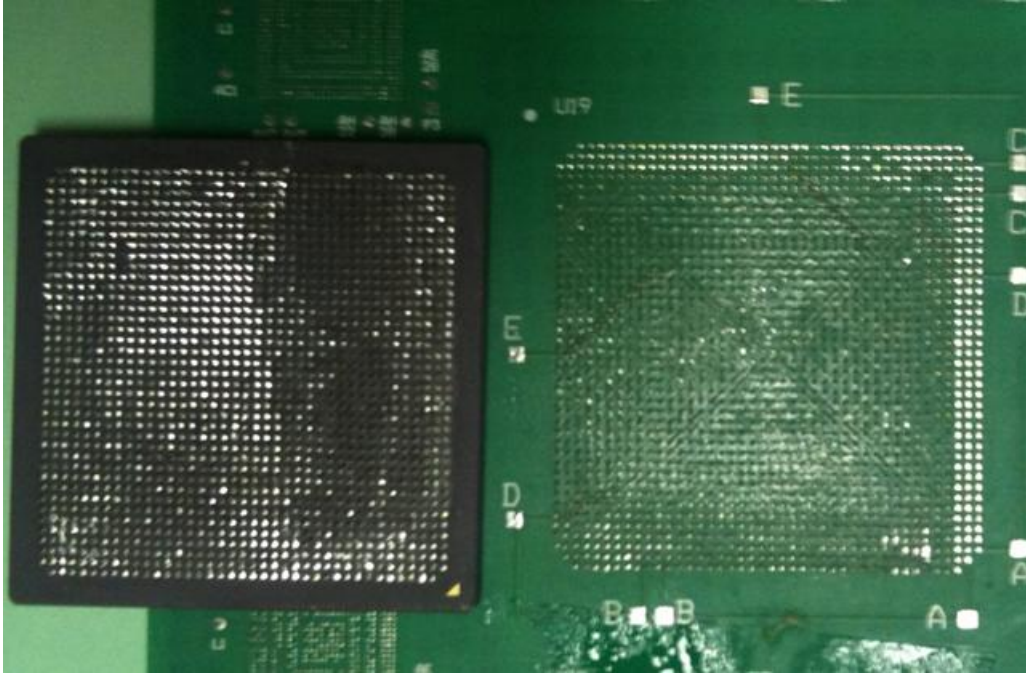
Figure 36. Rework of ceramic land grid array (LGA) package assembly show both package and PCB conditions.
